# Failure Analysis of Fractured Poppet from Space Shuttle Orbiter Flow Control Valve

Rick Russell  
Materials and Processes Engineer  
Materials Science Division, NE-L4  
Kennedy Space Center, Florida

# Failure of Space Shuttle Orbiter Flow Control Valve (FCV) Poppet

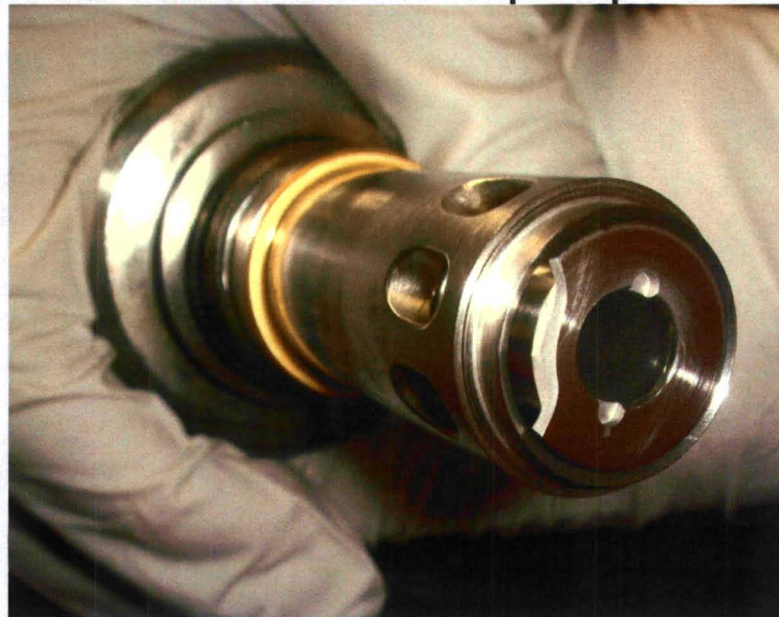
- During the ascent of *Endeavour* (OV-105) on Space Shuttle mission STS-126, the main propulsion system (MPS) engine #2  $\text{GH}_2$  flow control valve (FCV) appeared to make an un-commanded transition from the low-flow to high-flow position
  - This anomaly did not impact mission success
  - Post-mission disassembly of the FCV revealed that the poppet was fractured and a crescent-shaped piece was missing

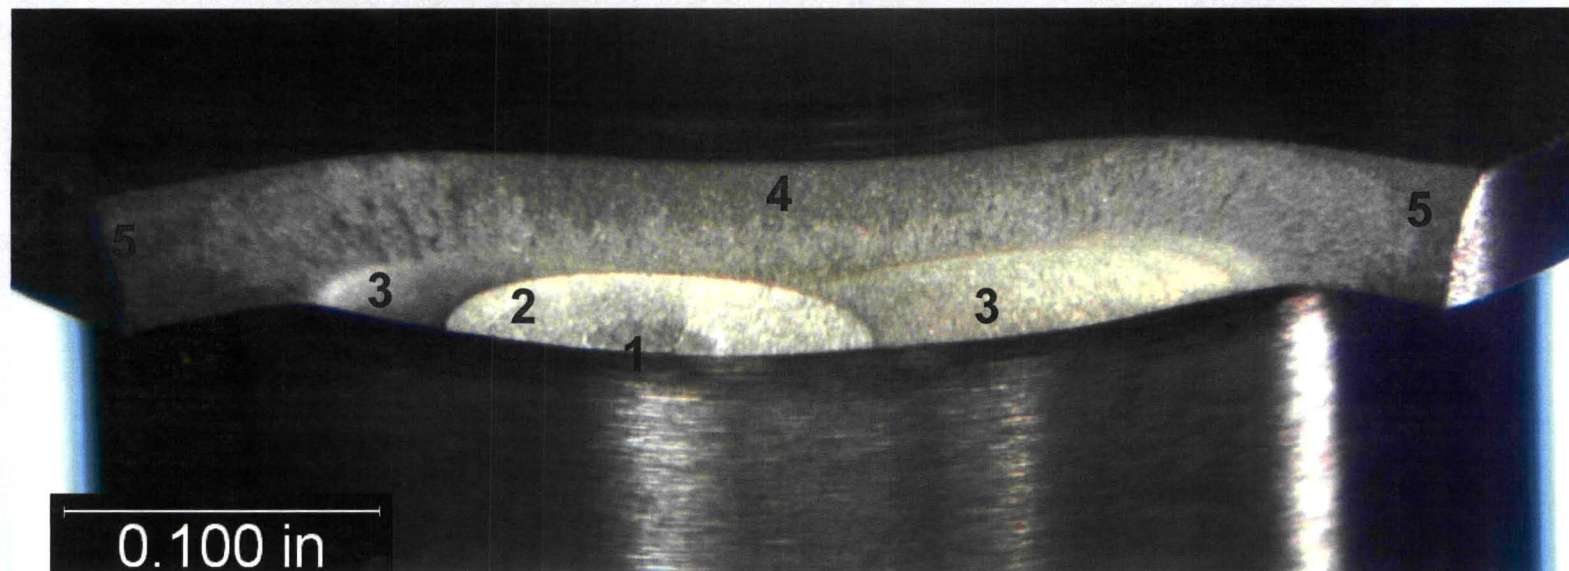
- Poppet fracture surface exhibited five (5) distinct zones:
  - Zones 1 & 2: Initial “thumbnails”
  - Zone 3’s (2): Circumferential propagation
  - Zone 4 & 5: Propagation through the flange and final fracture
- Fracture initiation occurred at middle of the body-to-flange radius and primarily propagated circumferentially along the radius, then through the flange thickness
  - The general plane of the fracture was  $\sim 45^\circ$  from the flange face

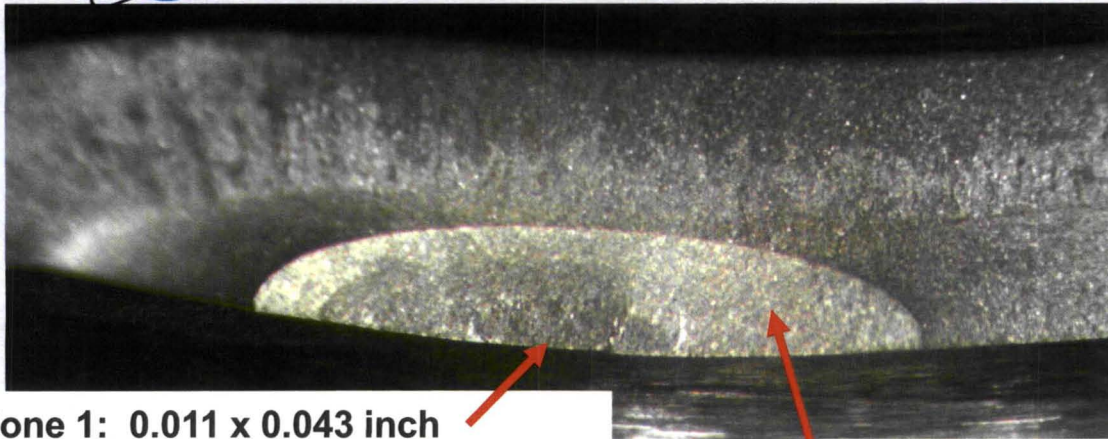
## Zones 1 & 2: Initial thumbnails

Zone 1: 0.011 x 0.043 inch

Zone 2: 0.026 x 0.133 inch

- Fracture initiated on two planes along the radius surface, then merged together into one plane

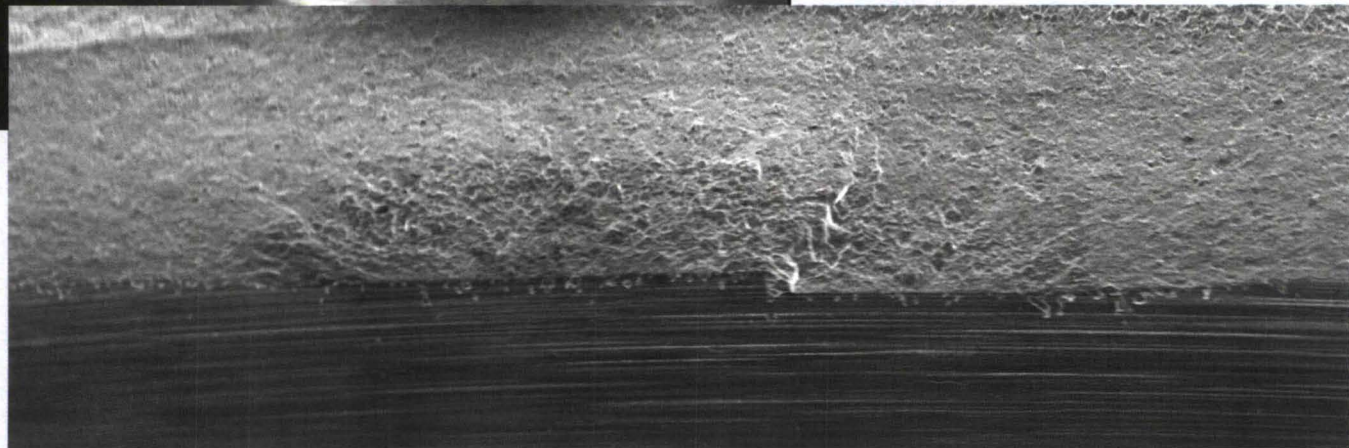
- Scanning electron fractography revealed:
- small, semi-planar areas
- rounded ridges
- exposed carbide particles,
- “divots”, which presumably resulted from spherical carbides being pulled out (i.e., carbide decohesion).
- No substantial secondary or intergranular cracking
- No striations

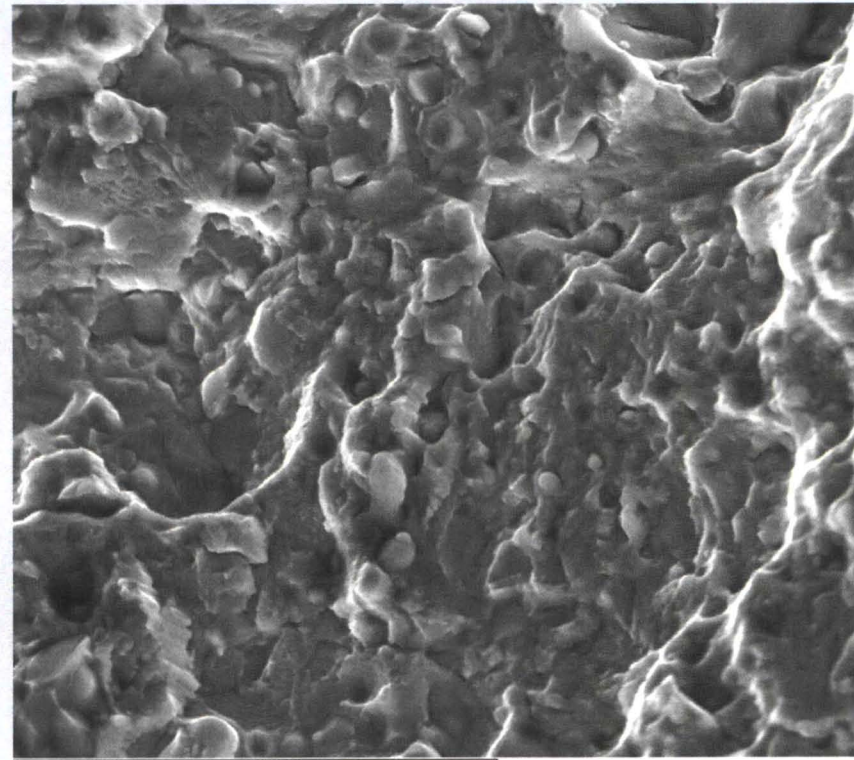
- In Zone 2, the fracture propagated on a less torturous path, exhibiting larger “semi-planar” regions, consisted with the smooth, shiny optical appearance. Otherwise, the features were fairly consistent with that of Zone 1.

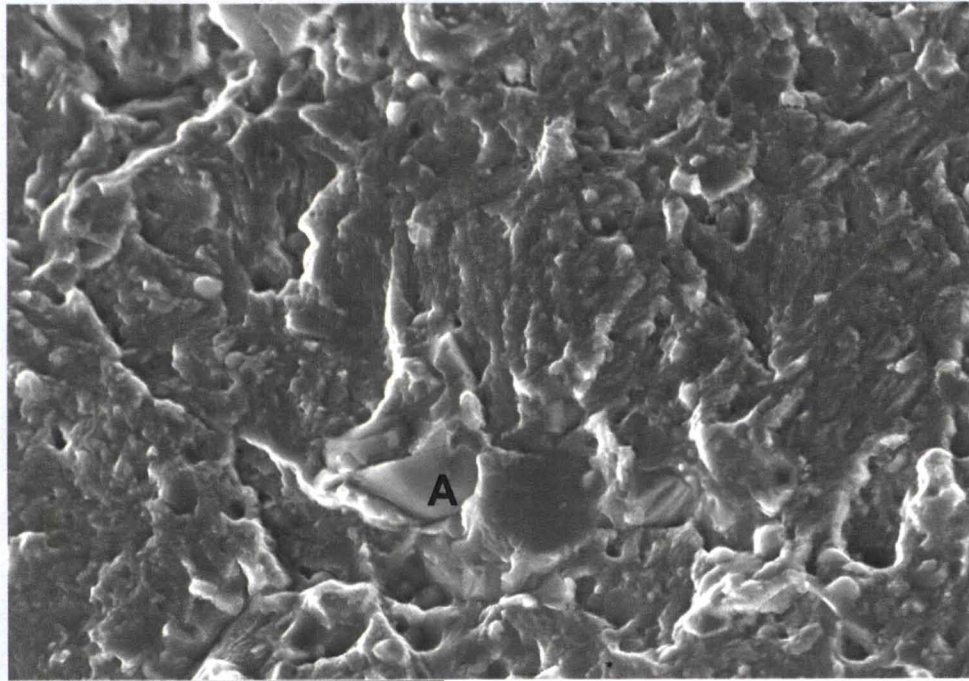
**A. Large  
blocky carbide  
typical of  
CRES 440**

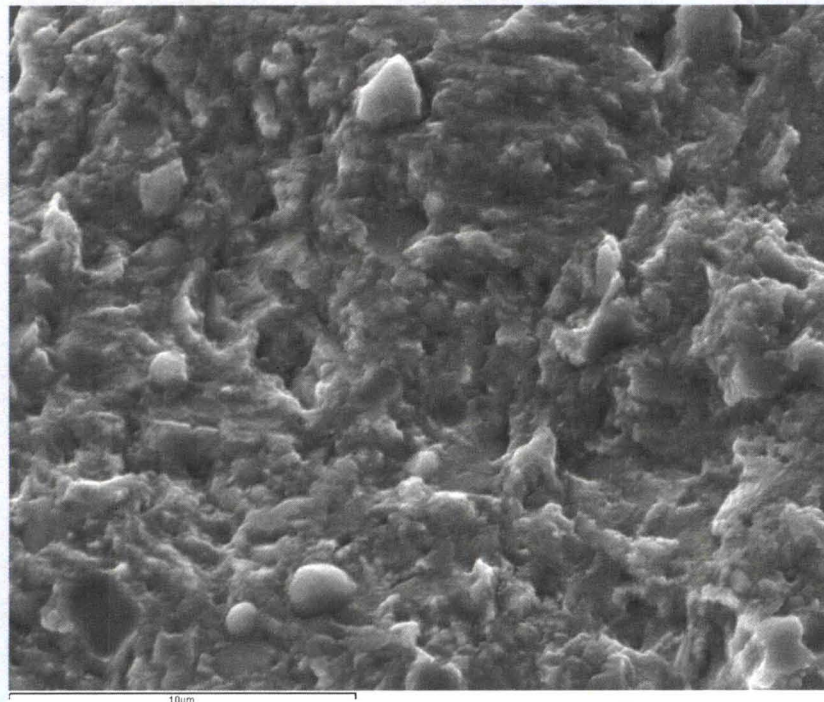
## Zone 3 “Wings”

- From the thumbnails, the fracture propagated circumferentially along the radius, not penetrating further into the flange thickness
- The topography of the fracture surface in the Zone 3 wings was similar to that of Zone 1

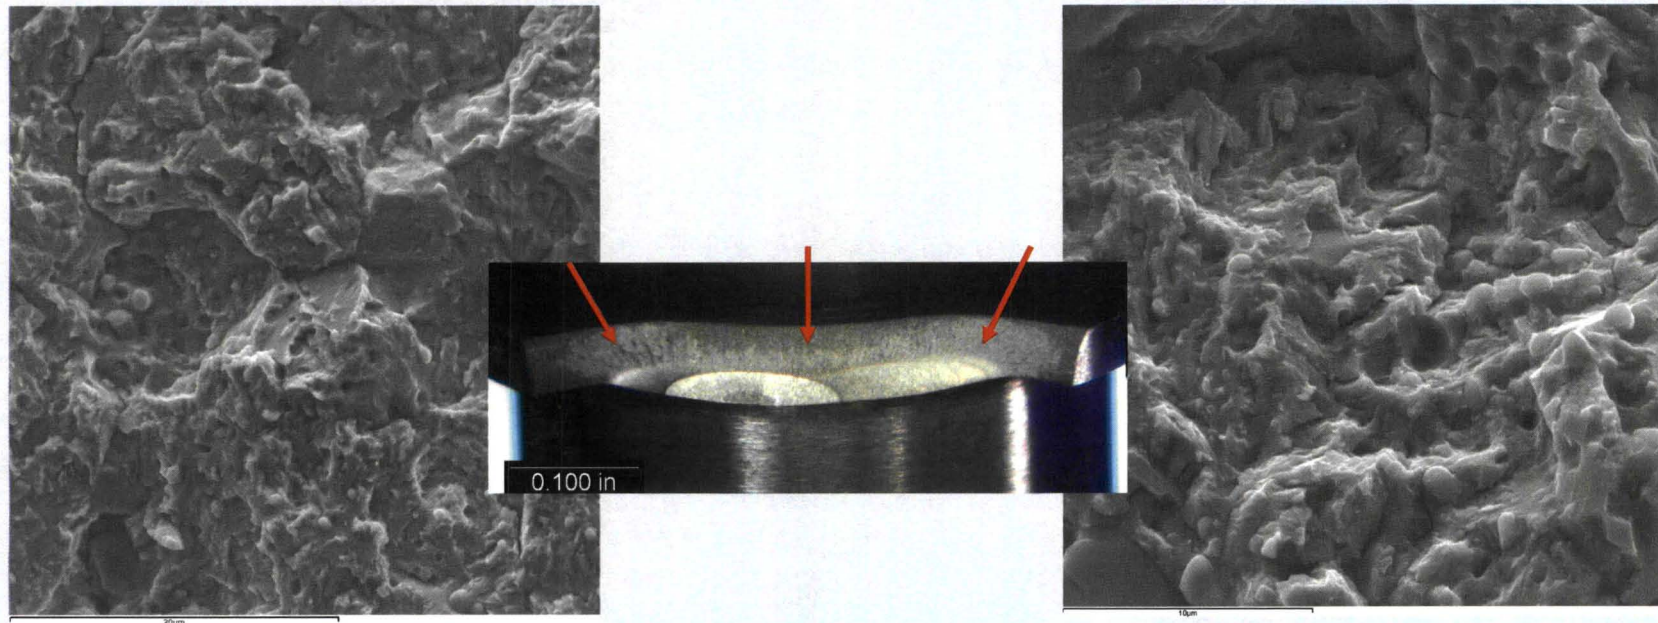
# Zone 4: Propagation through the flange

- The fracture surface increased in general roughness in Zone 4
  - Exhibited some secondary cracking
  - Sharper, more angular features
- Fracture toughness testing of 440A at NASA-MSFC in a 3400 psig  $\text{GH}_2$  environment clearly demonstrated that the features of Zone 4 were consistent with a sustained load cracking mechanism

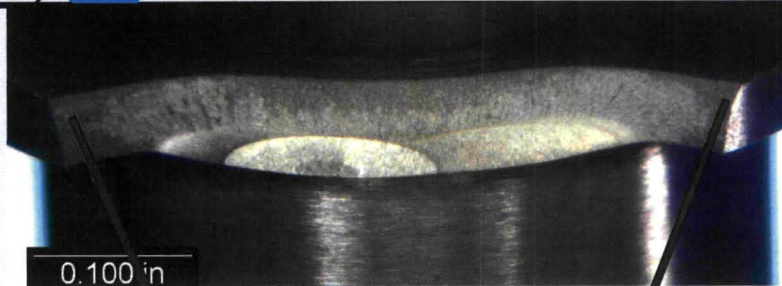
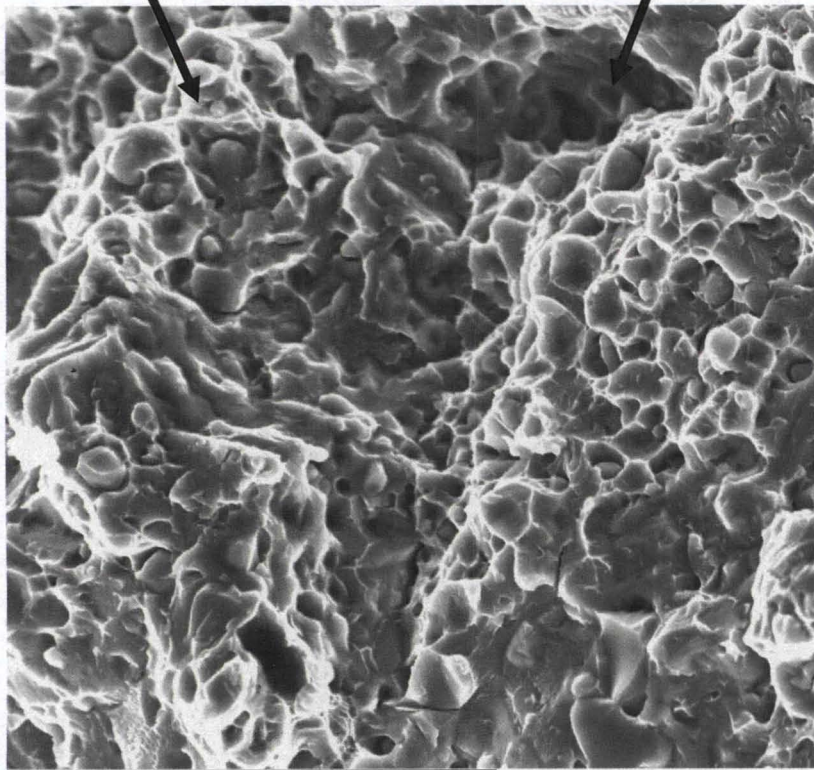
## Zone 5: Final fracture

- The Zone 5 “corners” exhibited a fracture surface typical of final, rapid overload
  - Primarily dimpled rupture

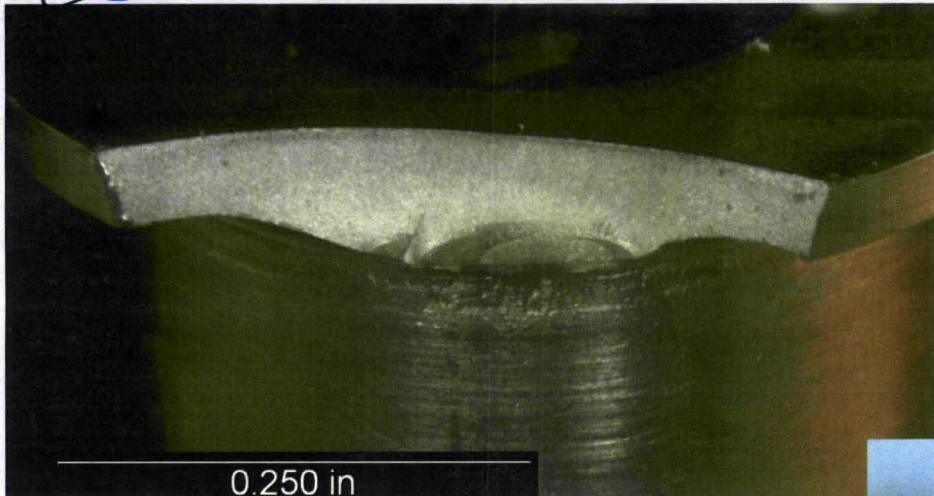
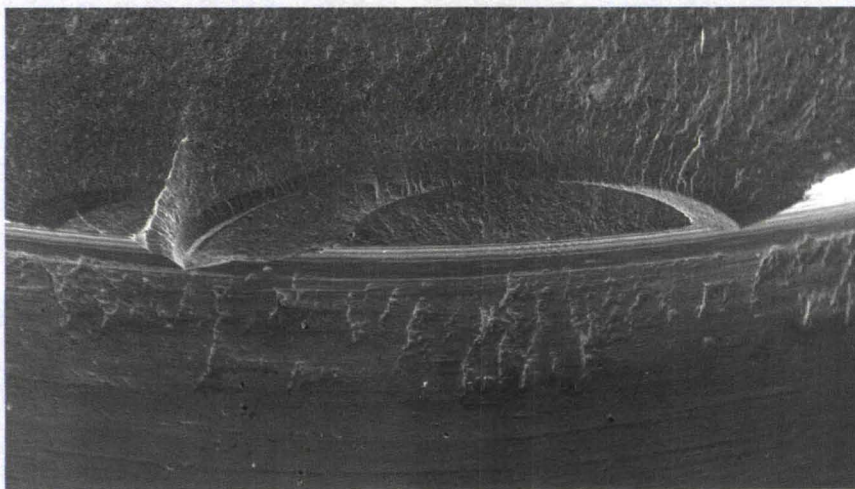
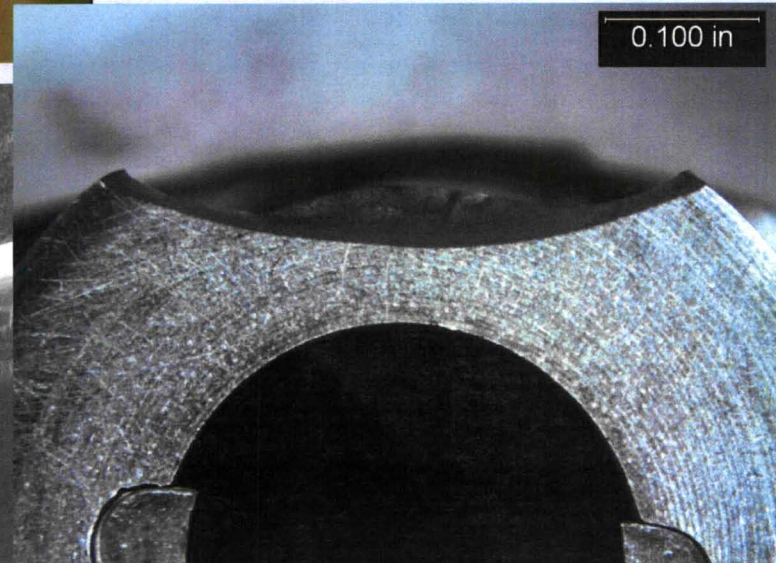
# Test Article Fractography

The thumbnail zones of the test articles exhibited fracture features that were very similar to that of the original failure
